MINUTES OF MEETING

Crowne Plaza Hotel/Atlanta Airport

April 2, 3, & 4, 2001

The objective of BLRBAC is to promote improved safety of chemical recovery boilers and their auxiliaries through the interchange of technical knowledge, experience, and data on past and any future recovery boiler incidents.

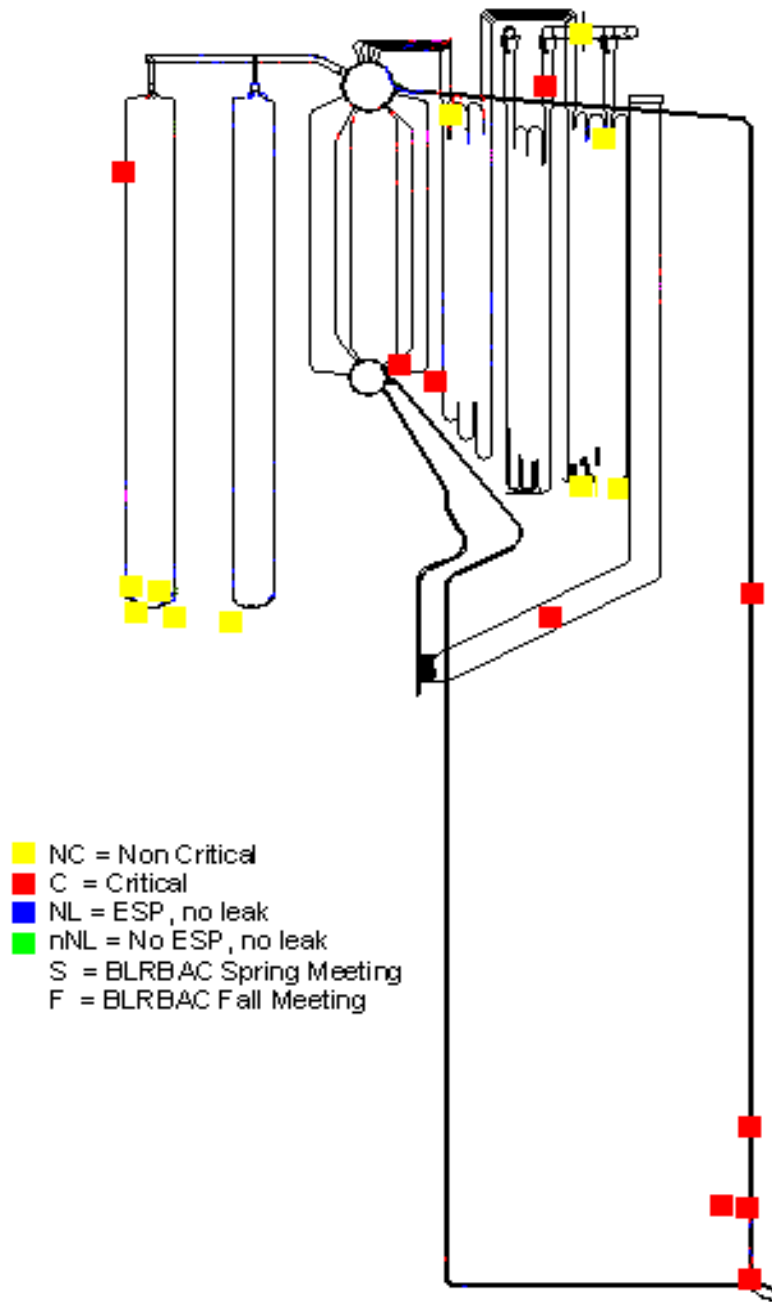
Figure 1

The leak locations that were reported are listed below and are also shown on a typical boiler cross section in Figure 1.

Leak Locations
Spring 2001

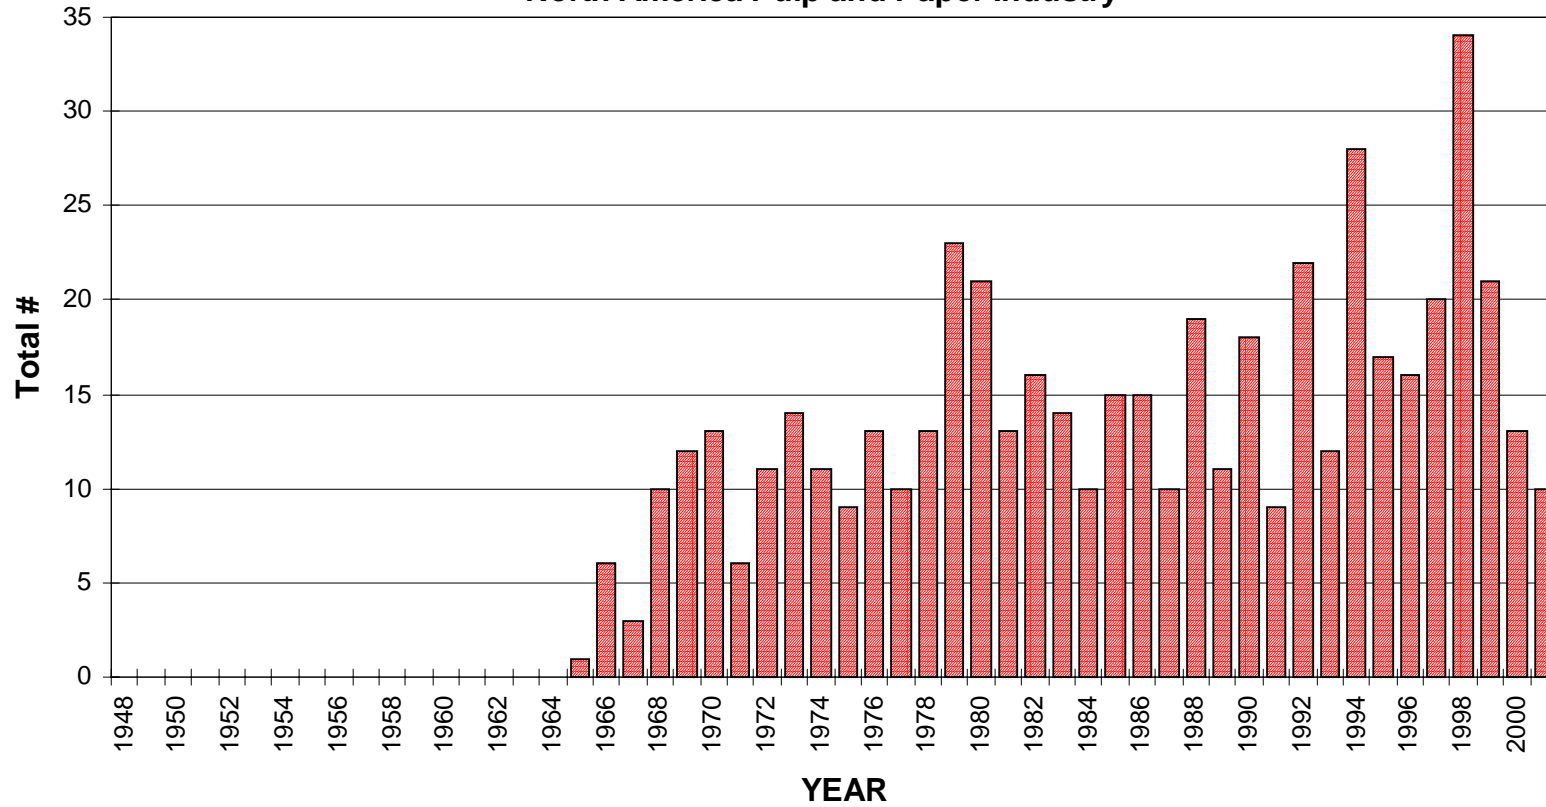
Figure 2 shows the number of Critical Incidents reported to BLRBAC each year. The data for 2001 to date contains only the incidents reported at the spring meeting (six months). It is interesting to note that even though the total number of reported incidents is lower than past meetings, the number of Critical Incidents is running about the same.

KRAFT RECOVERY BOILER CRITICAL INCIDENTS North America Pulp and Paper Industry

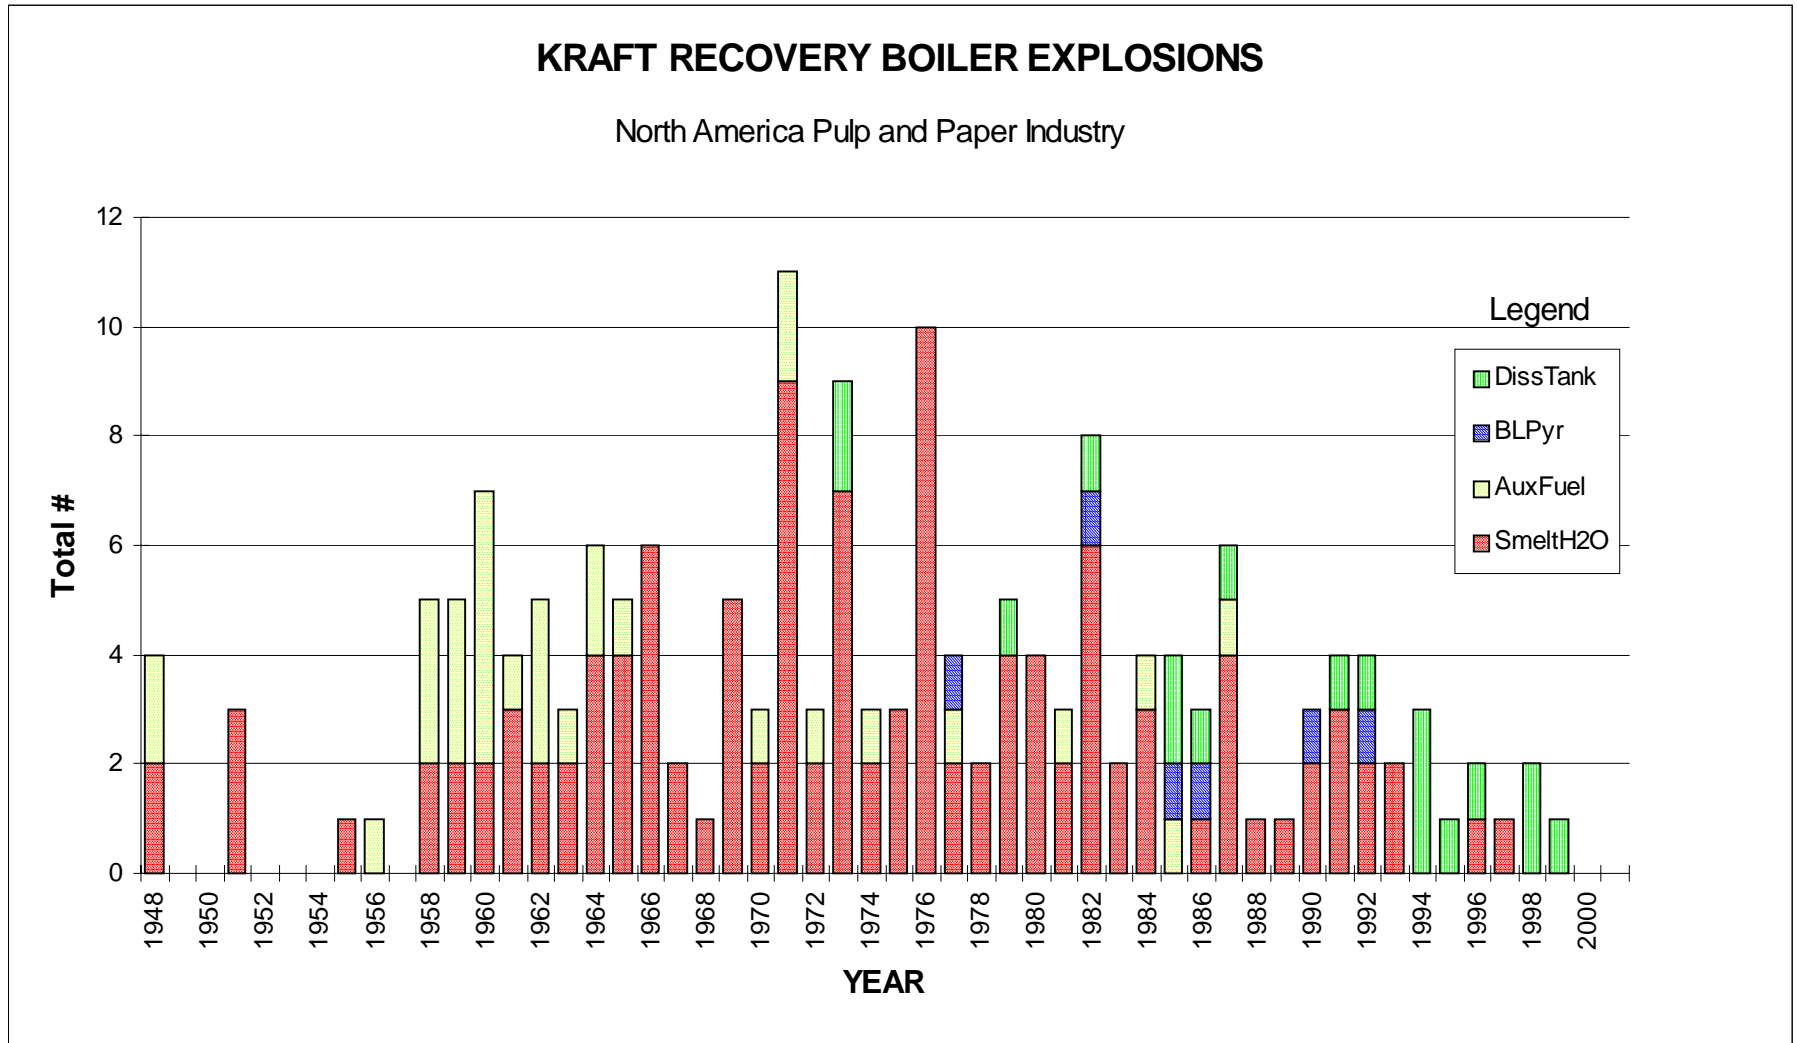
Figure 3 shows that the last smelt water explosion in the USA and Canada was reported in 1997 and there has not been an explosion of any type reported since 1999. This positive trend is reflected in Figures 4 and 5 as well. We all hope that this indicates improvement in operations throughout the industry as well as the positive influence of BLRBAC.

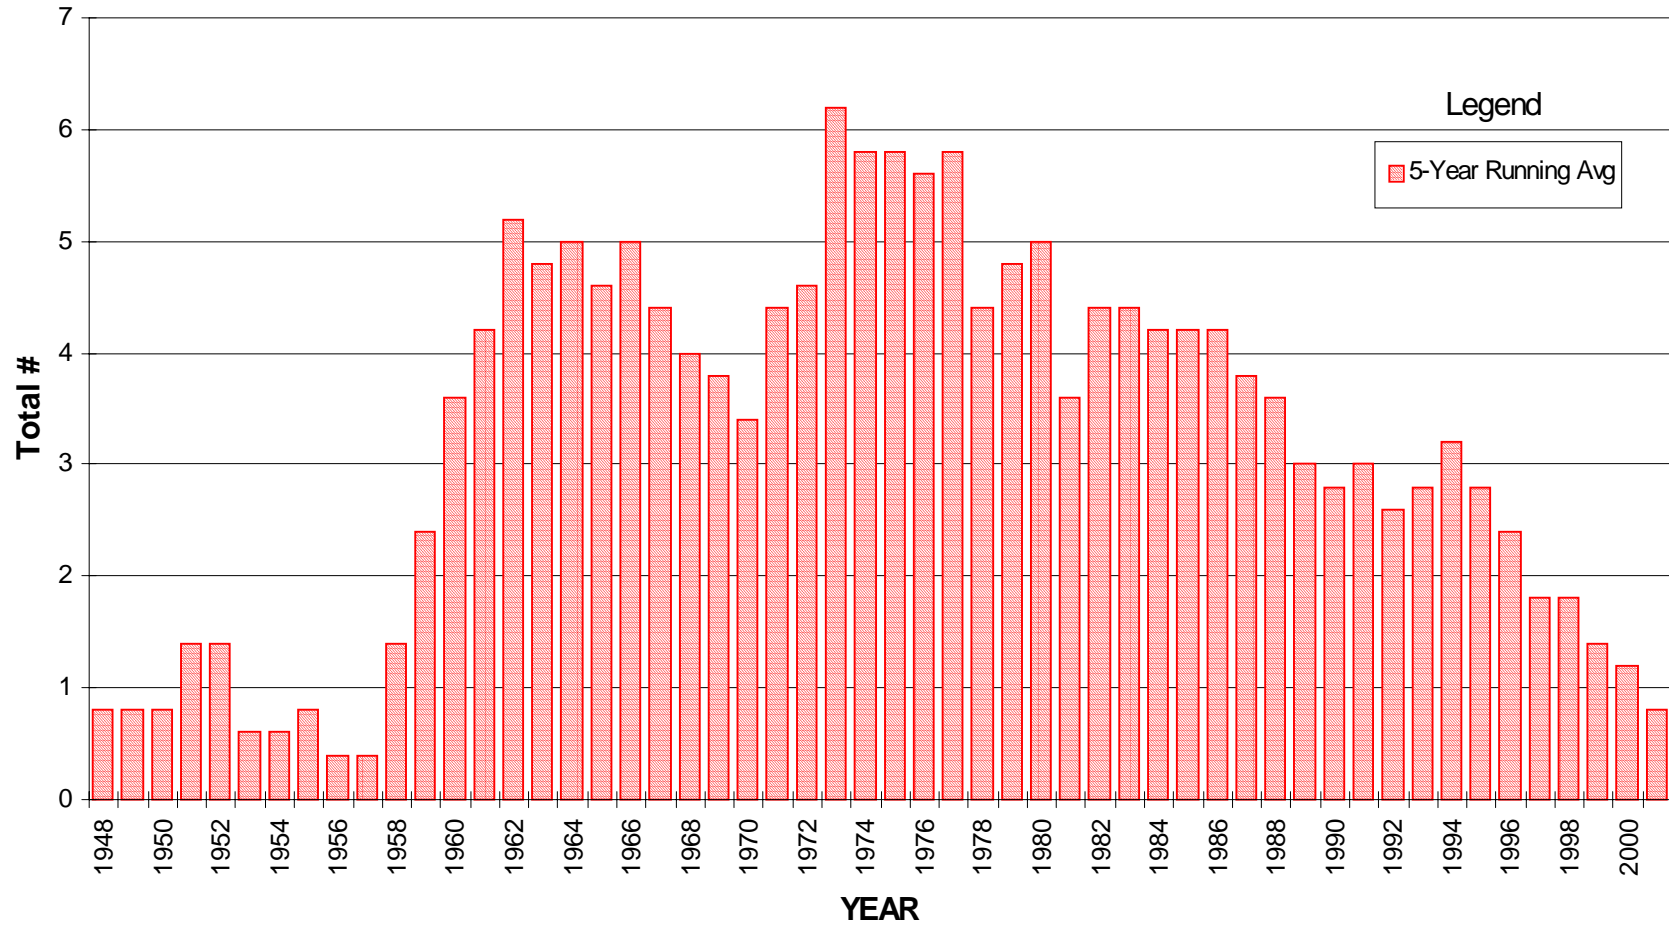
Figure 4

KRAFT RECOVERY BOILER EXPLOSIONS - Five Year Running Average

North America Pulp and Paper Industry

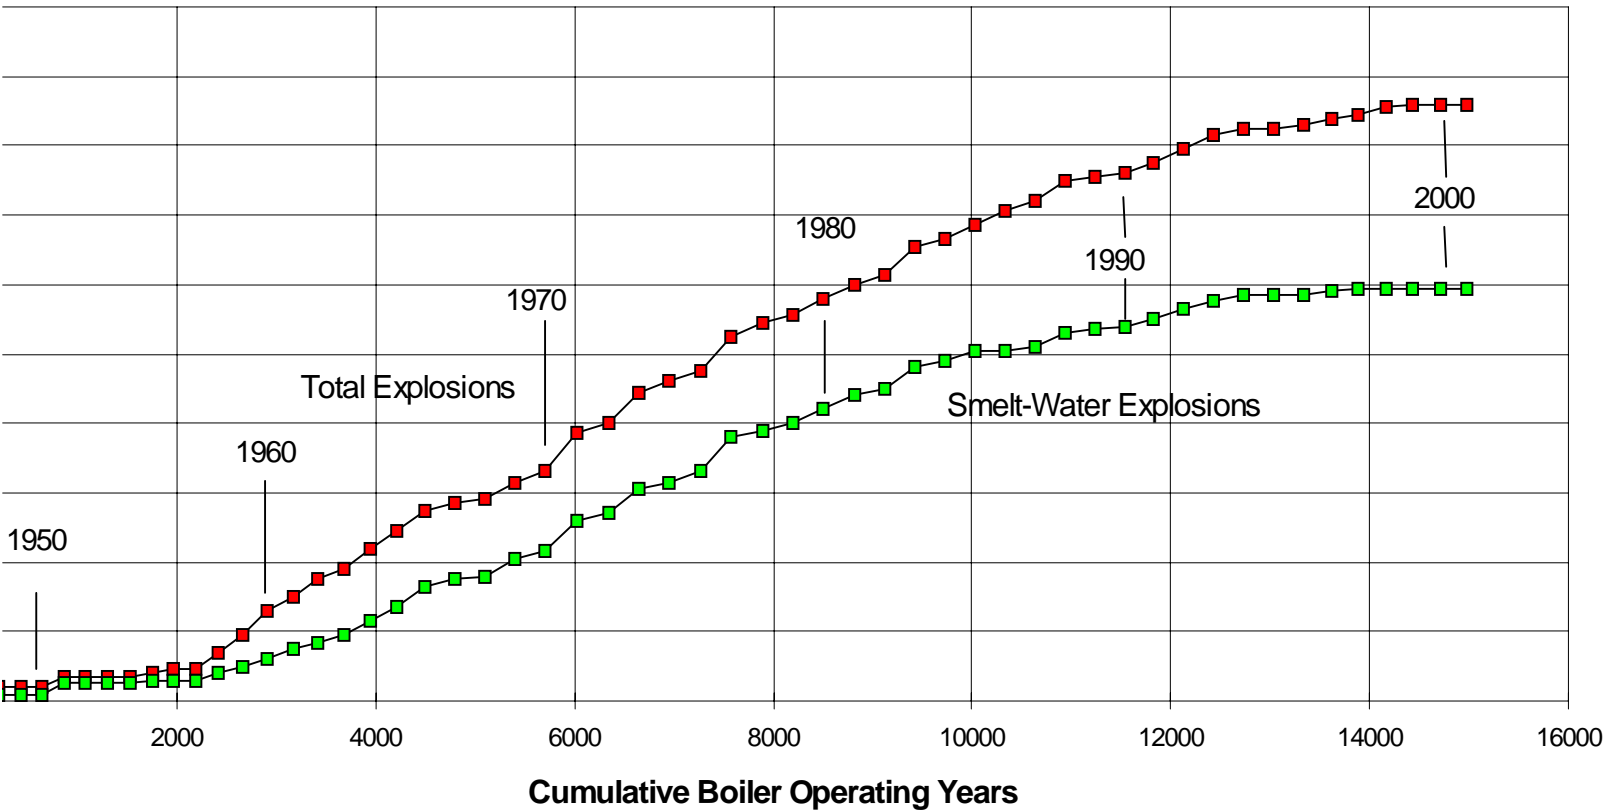
Figure 5

Cumulative Explosions per Cumulative Boiler Operating Years North America
