BLACK LIQUOR RECOVERY BOILER ADVISORY COMMITTEE

MINUTES OF MEETING Crowne Plaza Hotel/Atlanta Airport Atlanta, Georgia April 8, 9 & 10, 2002

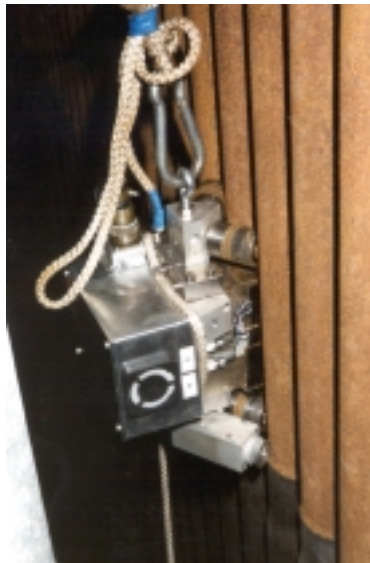
The tubes were initially examined with endoscope optics on the waterside, and finally with an eddy current device on the boiler side, see Figure 5. The damage turned out to be most severe on the straight tubes located next to the air port tubes.

Fig 5. The eddy current measuring device.

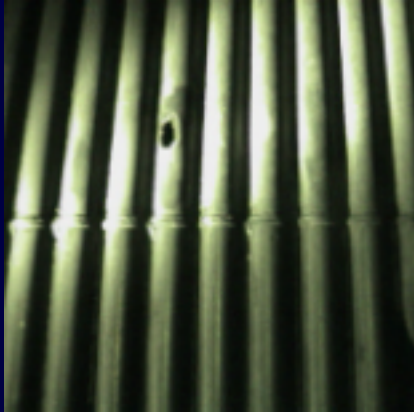
Hydrogen corrosion damage

- CE boiler from 1959
- Pressure reduced from 80 \Rightarrow 60 bar (1150 \Rightarrow 850 psig) before incident
- Wall tubes changed during 3 service stoppages
- Poor water quality
