BLACK LIQUOR RECOVERY BOILER ADVISORY COMMITTEE

OBJECTIVE

The objective of BLRBAC is to promote improved safety of chemical recovery boilers and their auxiliaries through the interchange of technical knowledge, experience, and data on past and any future recovery boiler incidents.

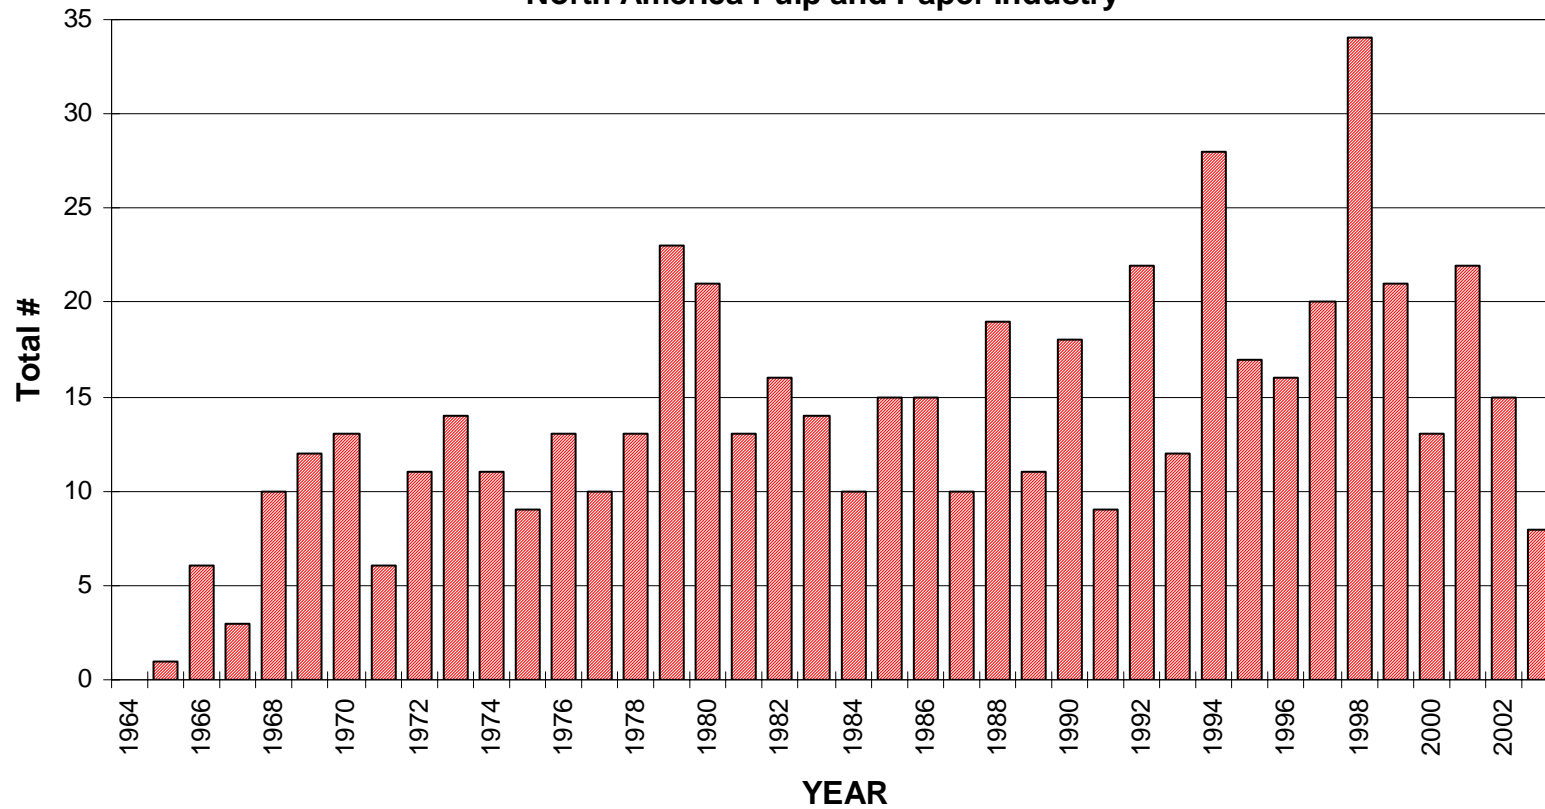
Figure 2 Critical Incidents (Classification Began in 1995)

Figure 2 shows the critical incidents per year. The last bar represents one-half the current year. If that is doubled for the full year, it appears that we are still running at rate of about 15 to 16 critical incidents per year.
