BLACK LIQUOR RECOVERY BOILER

ADVISORY COMMITTEE

Meeting Minutes

October 6, 7 & 8, 2003

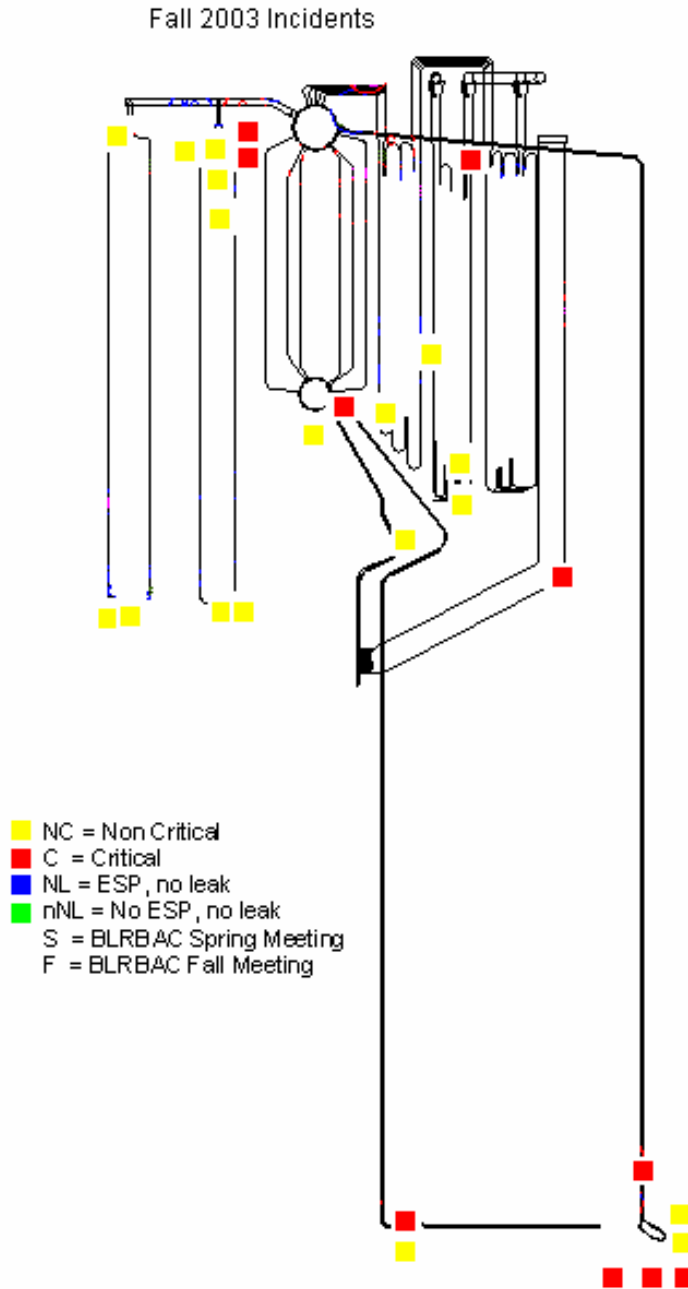
Figure 1

The general locations of the leaks are shown in Figure 1, which displays a typical boiler, not representing any particular style or model. The yellow marks are the non-critical incidents and the red were listed as critical incidents. The leaks locations are summarized as follows:

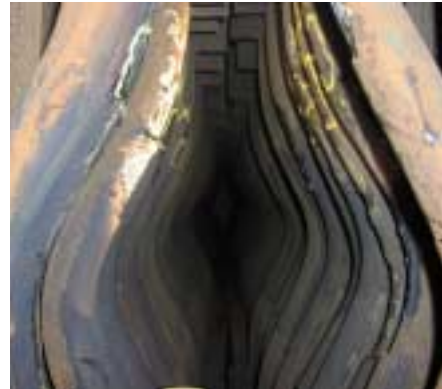
Here we see some pictures. This one shows sootblower passage damage.

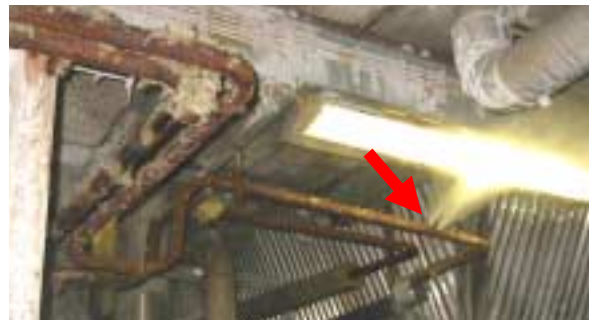
On this economizer we can see that leak on the pipe here. It's an old boiler that will be replaced next year.

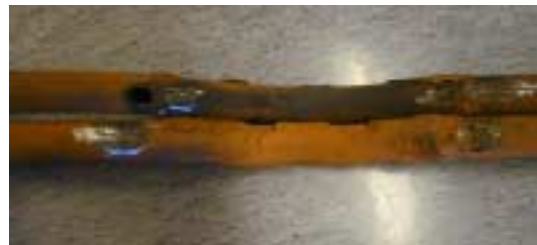
This is a steam distribution tube that is corroded by washing water from the outside.

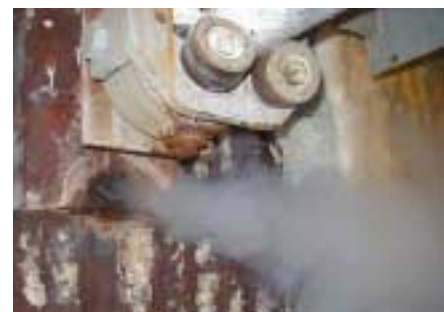
Here we have a leaking wall tube with corrosion from the outside as well.

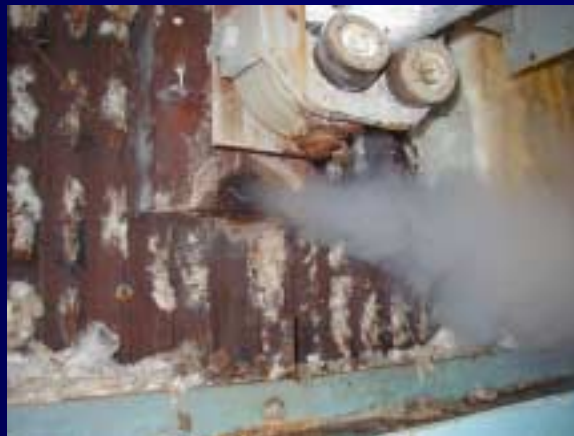
Corroded wall tube

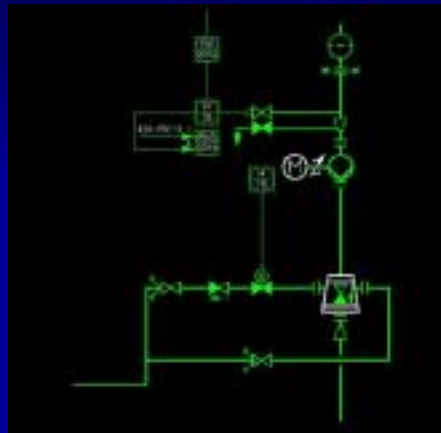
FW line leak

- A valve in the FW by pass line leaked
- Erosion caused pipe to break during service
- Carbon steel not erosion resistant

Here we have an interesting incident. This picture is not from the mill. It is a similar picture. One of these valves was leaking. They were planning to replace it. When they tried to detach the valve, the whole line broke down. This line is just a pump and a bypass line back to the feed water tank. This line was carbon steel and if the valve is leaking then the lines could corrode. So, our message was that this line when replaced should be of at least some degree of stainless steel. This would make it more corrosion resistant. I think it was ½ mm. This line had been 6.3 originally. This is not an old mill.
