BLACK LIQUOR RECOVERY BOILER

ADVISORY COMMITTEE

Meeting Minutes

April 5, 6, & 7, 2004

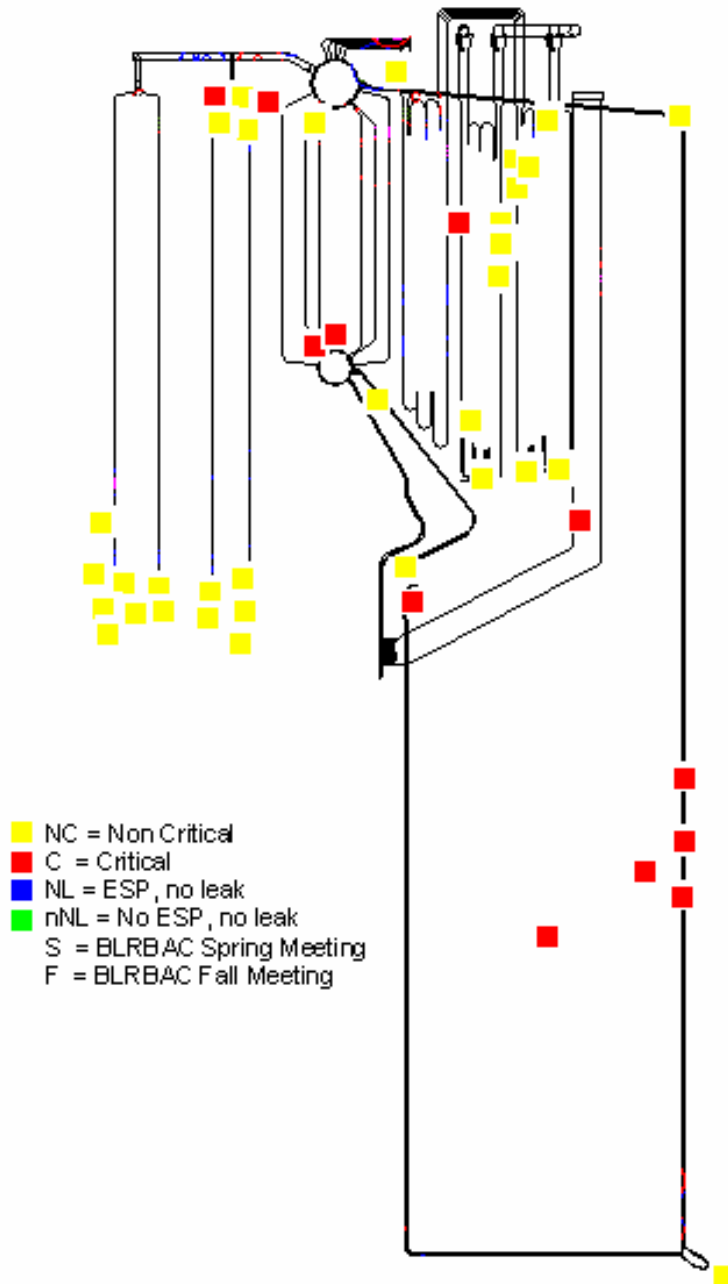
Figure 1

The general locations of the leaks for boilers in North America are shown in Figure 1, which displays a typical boiler, not representing any particular style or model. The yellow marks are the non-critical incidents and the red were listed as critical incidents. The leaks locations are summarized as follows:

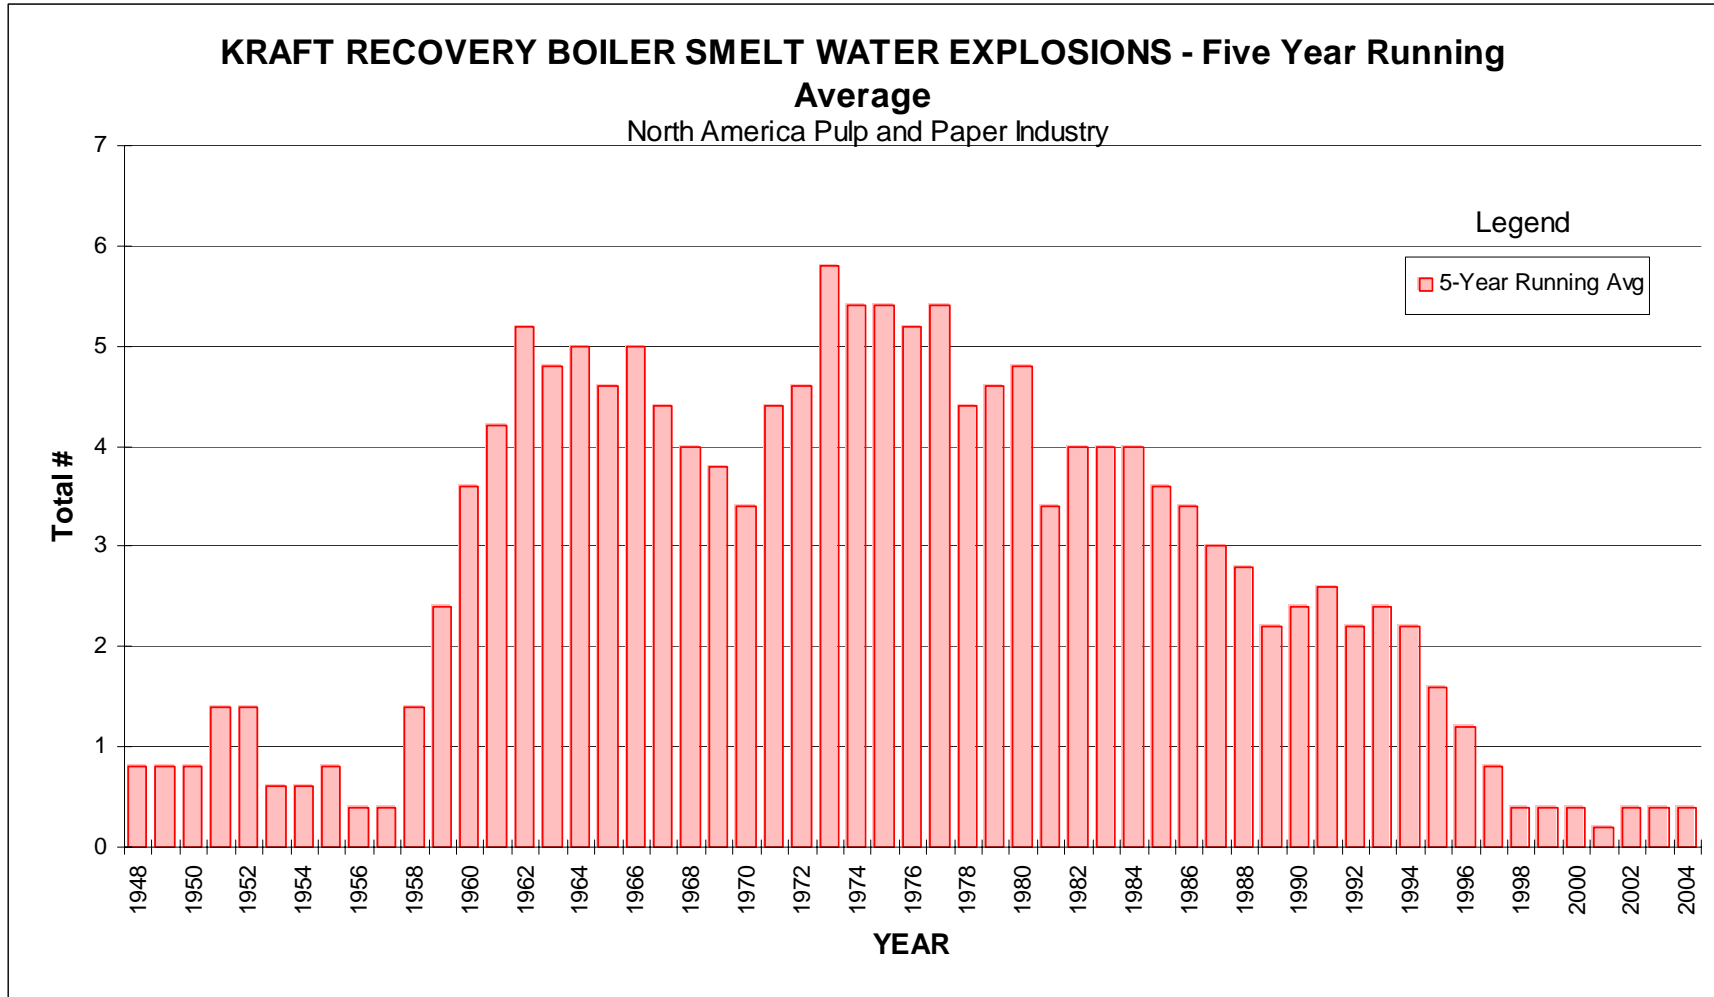
Figure 4 shows the five year running average of smelt water explosions and gives a good indication of the progress that has been made in reducing smelt water explosions with only two incidents reported in the last 5 years.
