BLACK LIQUOR RECOVERY BOILER ADVISORY COMMITTEE

MINUTES OF MEETING

April 4, 5, & 6, 2005

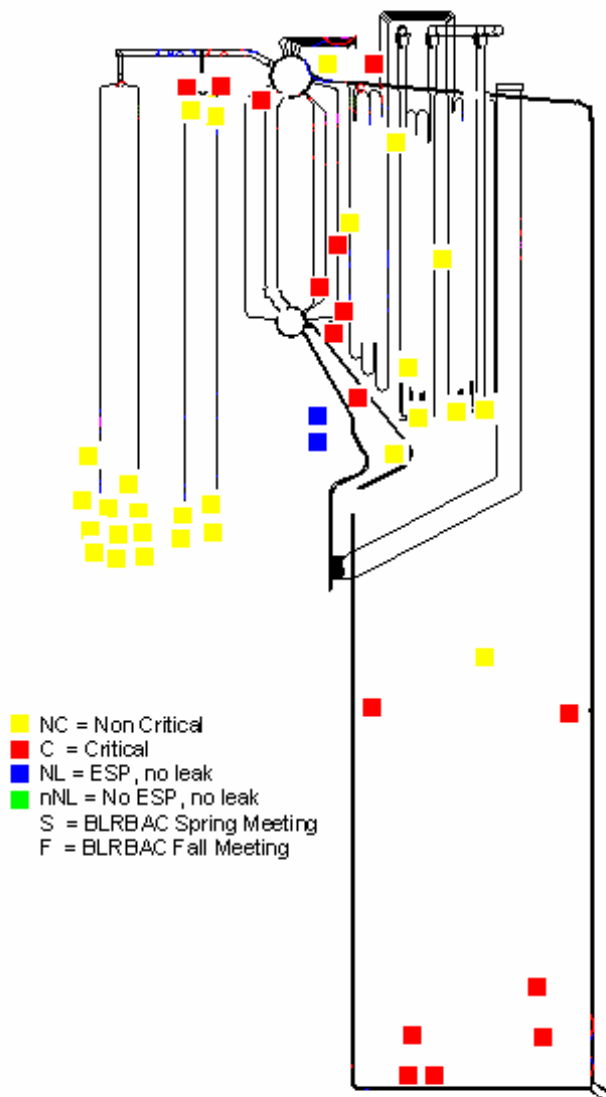
Figure 1

Spring 2005 Incident Locations

The general locations of the leaks for boilers in North America are shown in Figure 1, which displays a typical boiler, not representing any particular style or model. The yellow marks are the non-critical incidents and the red were listed as critical incidents. The leaks locations are summarized as follows:

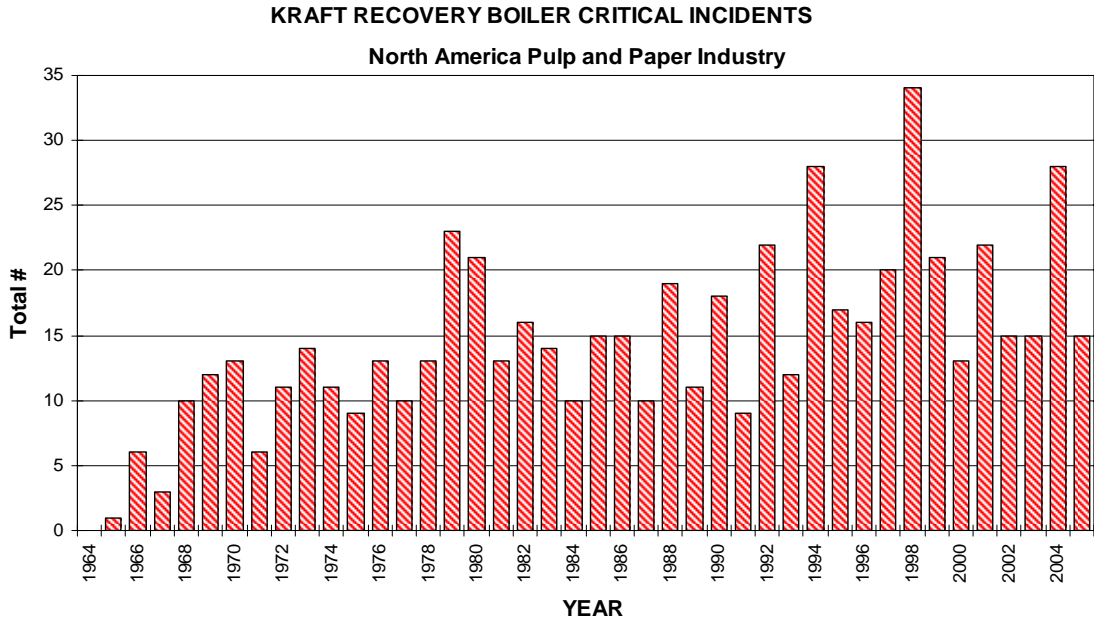
(Critical Incident Classification Began in 1995)

Figure 2 shows the critical incidents reported each year. The 15 critical incidents reported this year represent half a year so most likely the total for the year will continue to be above the recent average.
