BLACK LIQUOR RECOVERY BOILER ADVISORY COMMITTEE

MINUTES OF MEETING Crowne Plaza Hotel/Atlanta Airport Atlanta, Georgia April 8, 9 & 10, 2013

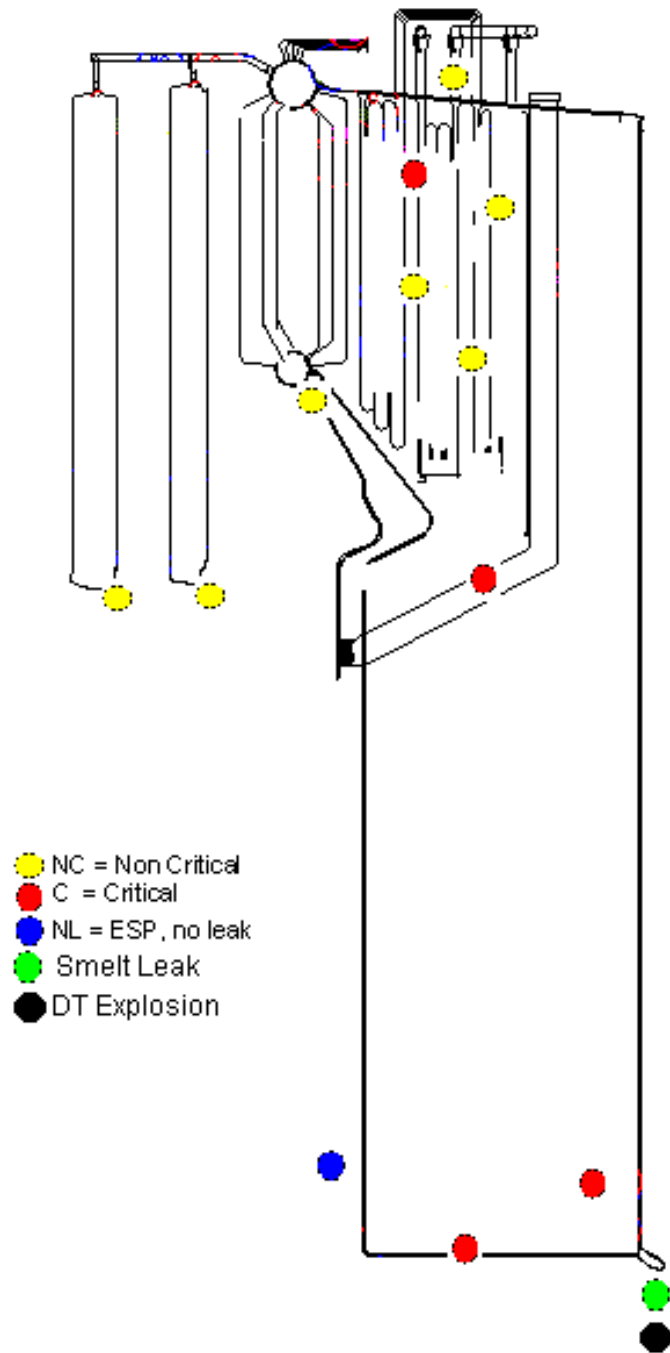
Figure 1

The general locations of the leaks for boilers in North America are shown in Figure 1, which displays a typical boiler, not representing any particular style or model. The yellow marks are the non-critical incidents and the red marks indicate the location of the critical incidents. The spout failure is indicated by green dot at the spout level and the blue dot is for the ESP with no leak. The general location for those represents an estimate of where the suspected leak was located. The black dot under the spout indicates the Dissolving Tank Explosion

Spring 2013 Incidents

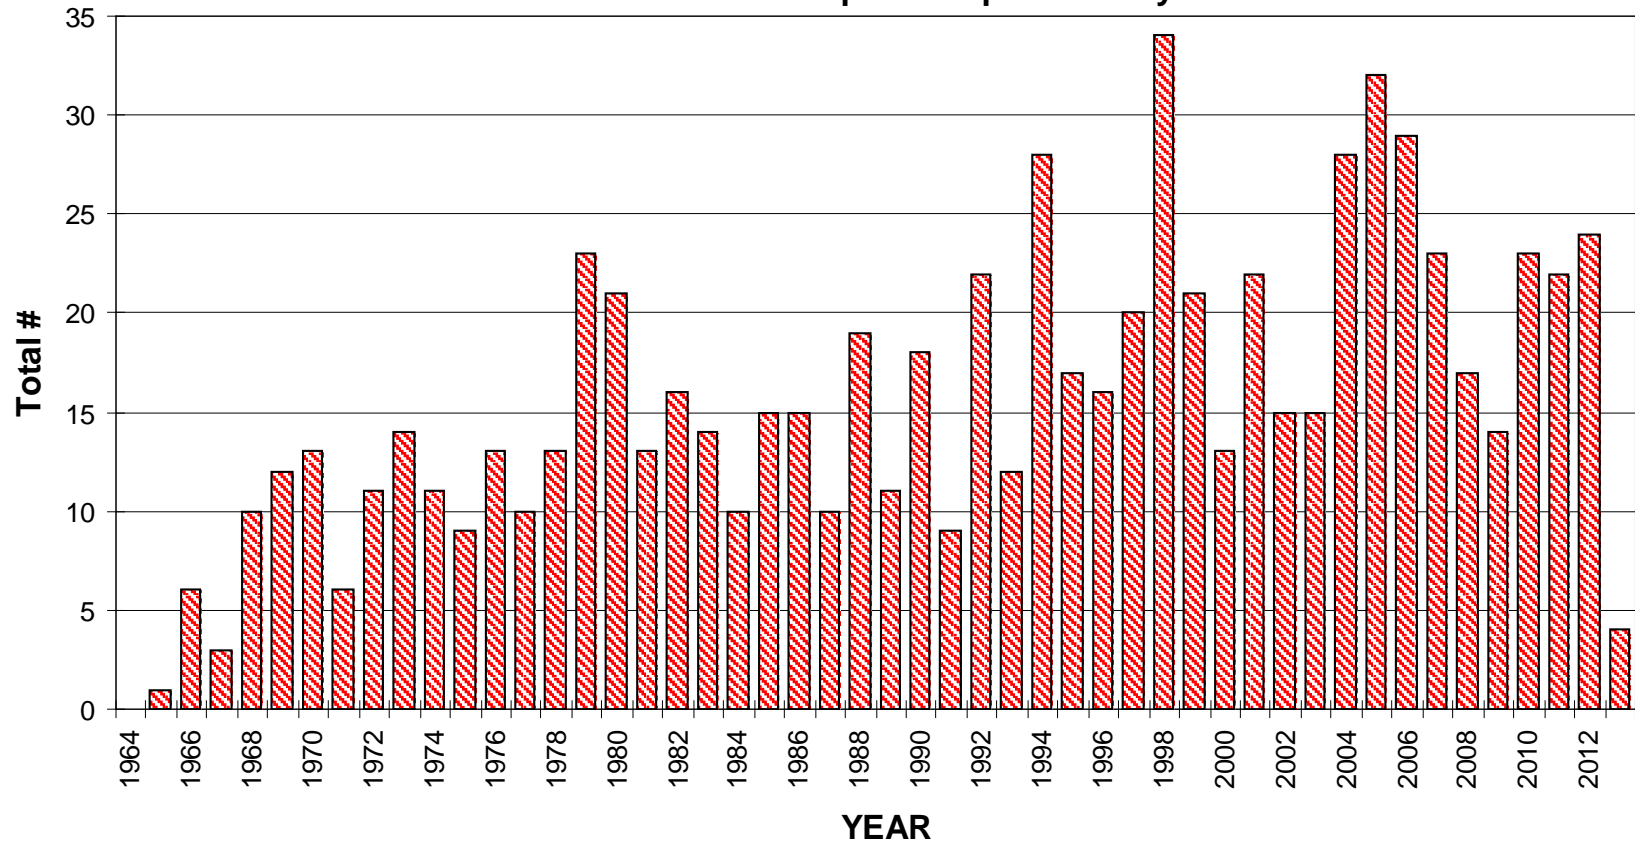
Figure 2
(Critical Exposure Classification Began in 1965, Changed to Critical Incident in 1999)

Figure 2 shows the critical incidents reported each year. The bar for 2013 only represents half a year and several incident reports have just been received that will be reported in the fall. Figure 3 shows the history of Recovery Boiler Explosions showing the smelt water explosion reported last year.

KRAFT RECOVERY BOILER CRITICAL INCIDENTS North America Pulp and Paper Industry

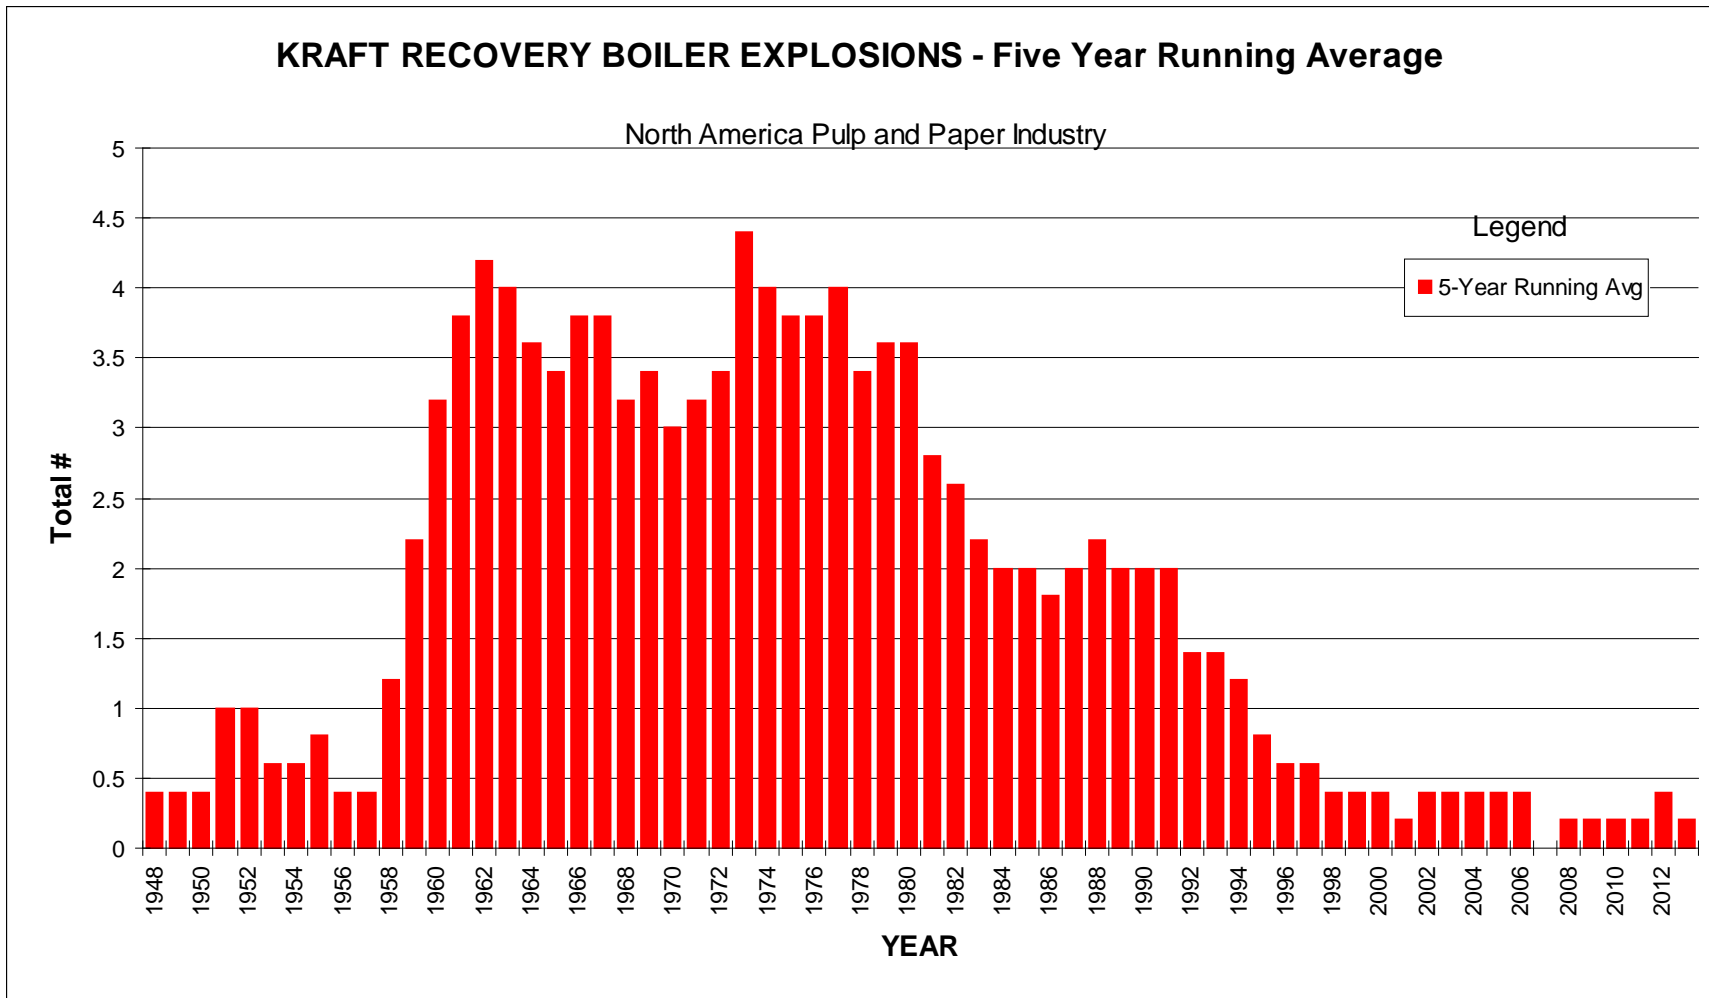
Figure 4 shows the effect of last years smelt water explosion on the five year rolling average which is back to 0.2. Maybe in another four years we can get back down to zero!

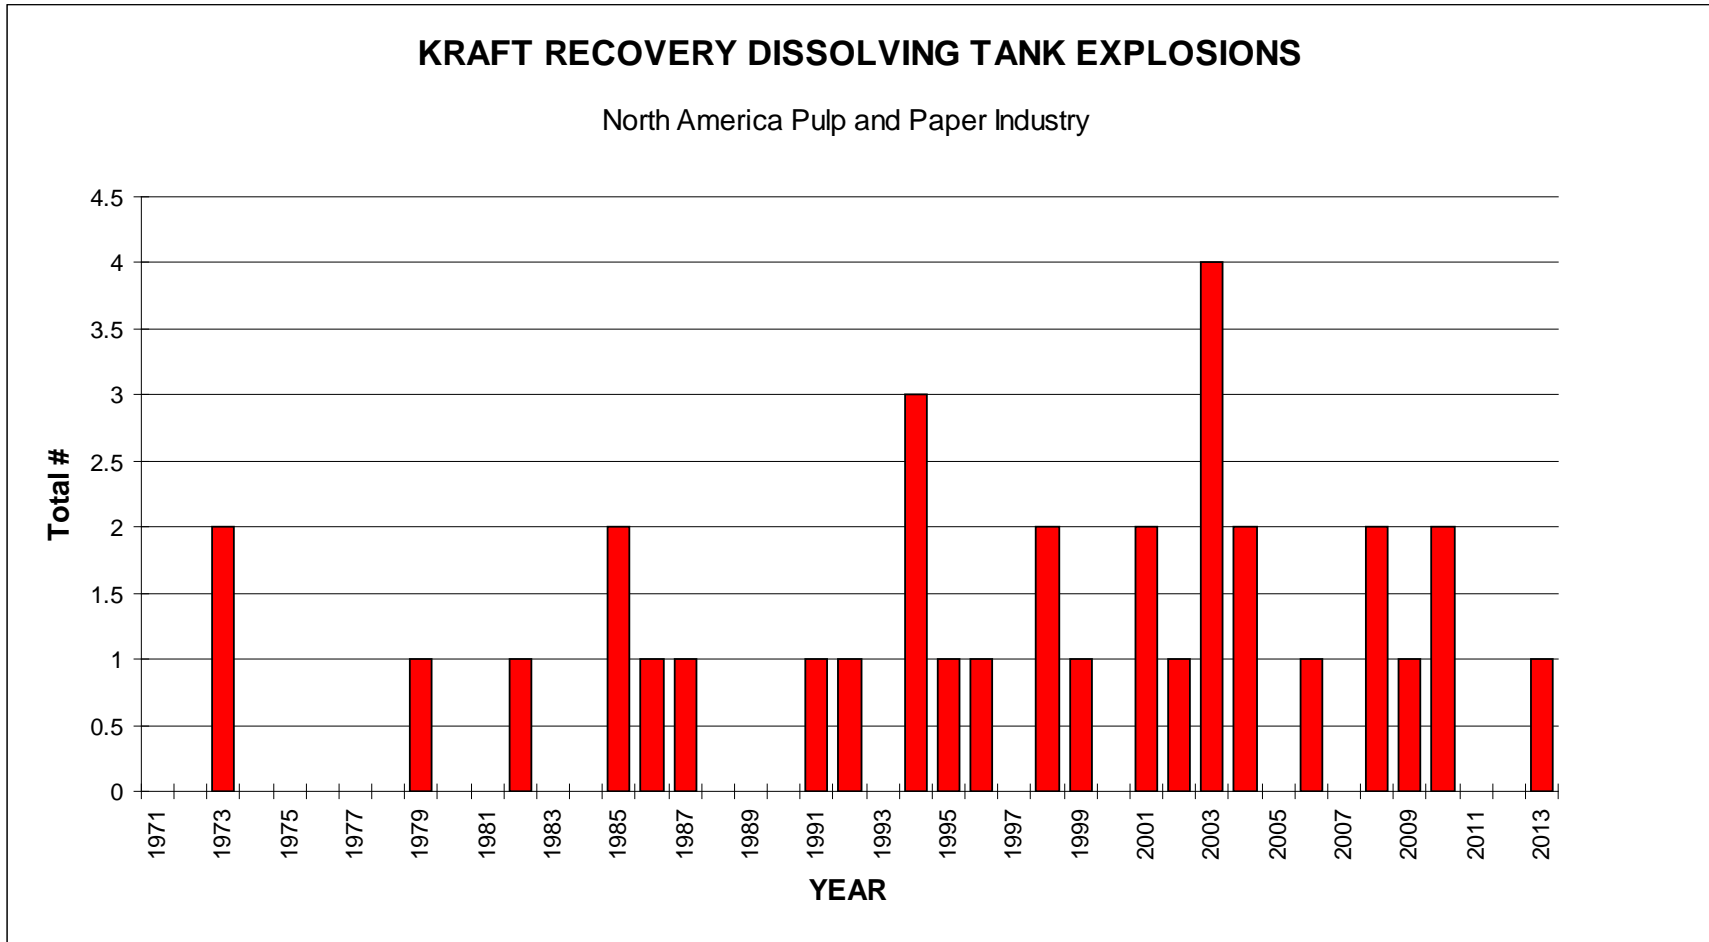
Figure 5 shows the history of dissolving tank explosions and we broke the string of no dissolving tank explosions for the last couple of years. Following the recommendations from Section 10 of the Safe Firing of Black Liquor document would prevent many of the reported dissolving than incidents that have occurred in the past.

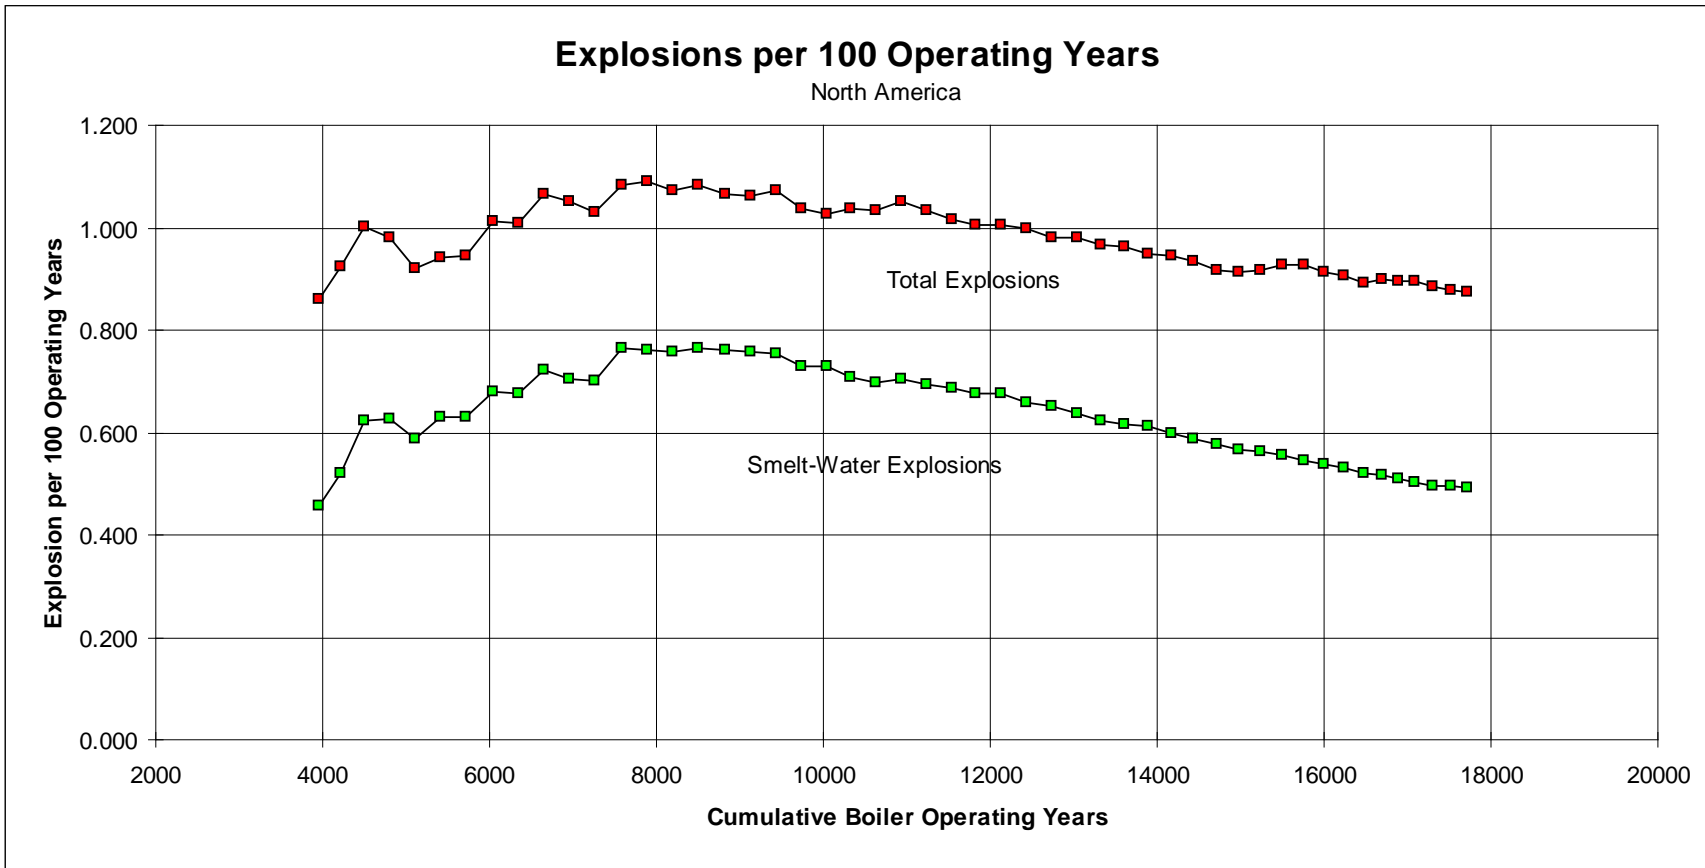
Figure 6 is a plot of explosion history per 100-boiler operating years. This is a statistical summary of the experience across the industry. The smelt water explosion experience is continuing to trend down over time and is down to 0.5 explosions per 100 boiler operating years, and the total explosions, which includes all boiler explosions and dissolving tank explosions, decreased to under 0.9 explosions per 100 boiler years since no dissolving tank explosions were reported last year.
